PROJECT BACKGROUND

Project Details

DESIGN ALIGNMENT

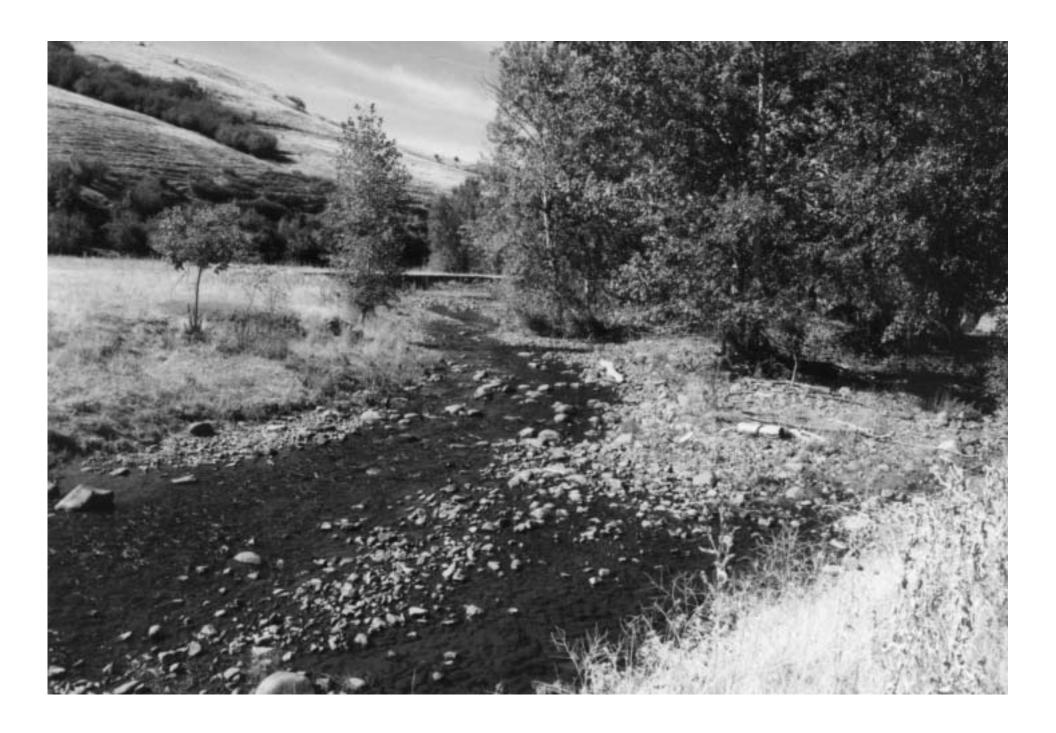
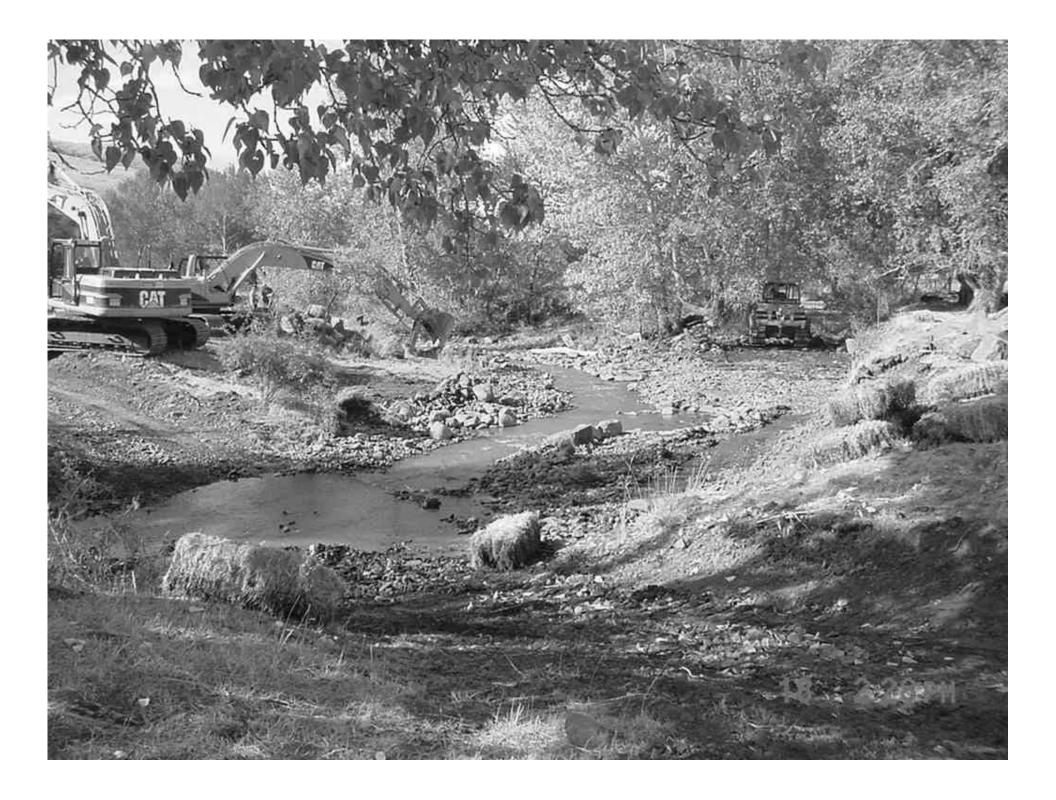
- Prior to Restoration
 - Wide and flat bottomed
 - 28 76 ft bankfull width with average of 39 ft
- After Construction
 - Average bankfull width 28 ft.
 - Late summer flows consolidated into 10 ft wide low flow channel

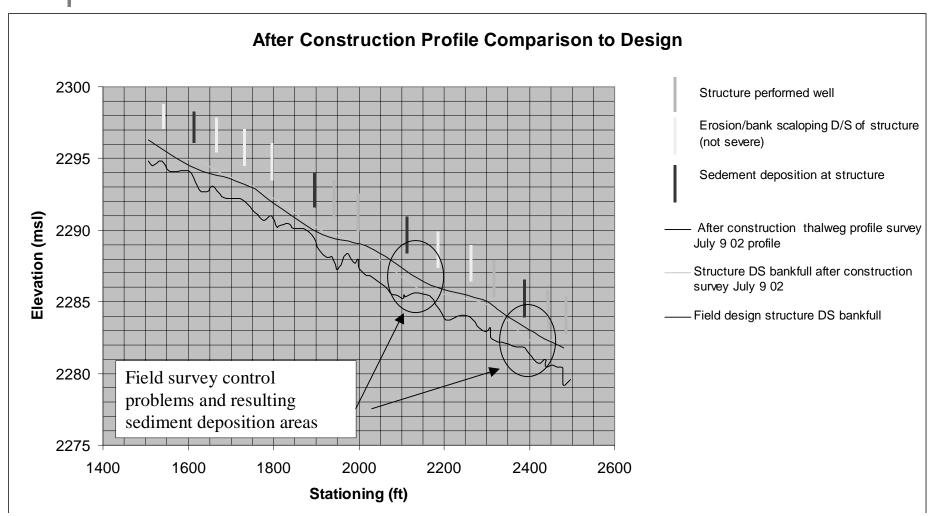
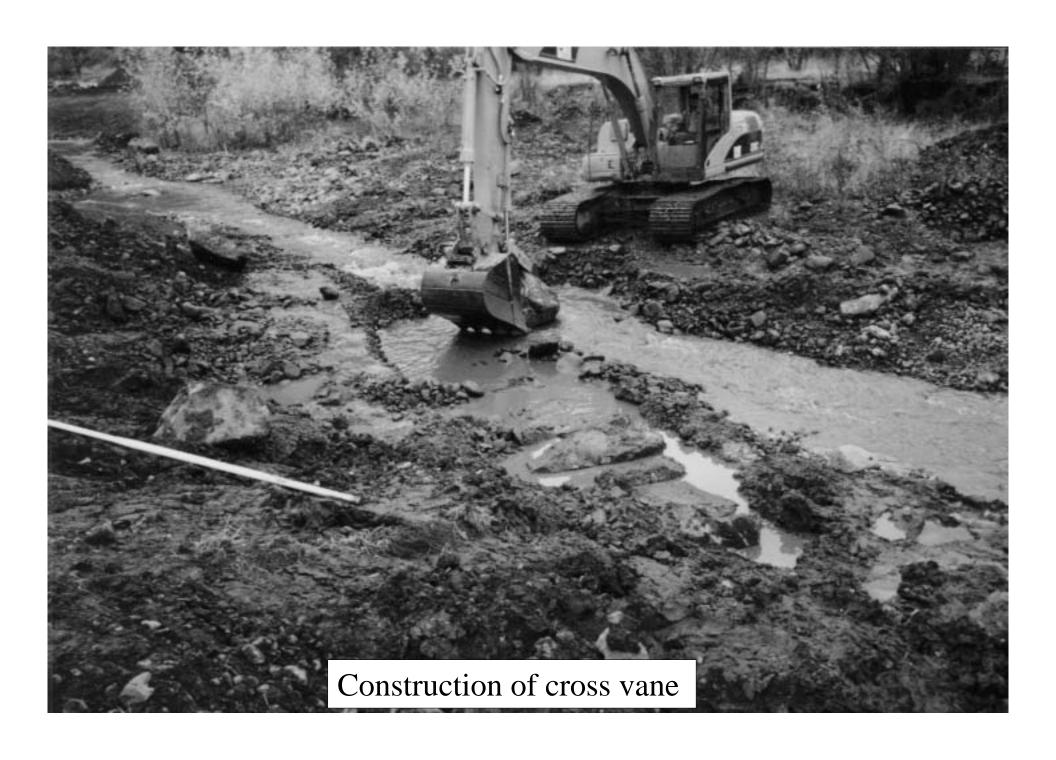
Profile for Bankfull

- •Trying to work stone down to design elevation (note is too high)
- •Surveyed surface often underwater in poor visibility conditions
